Assessing the Risk of Lead Exposure to Children from Drinking Water in Metro Vancouver Child Care Facilities

Thomas Quach

Project Purpose

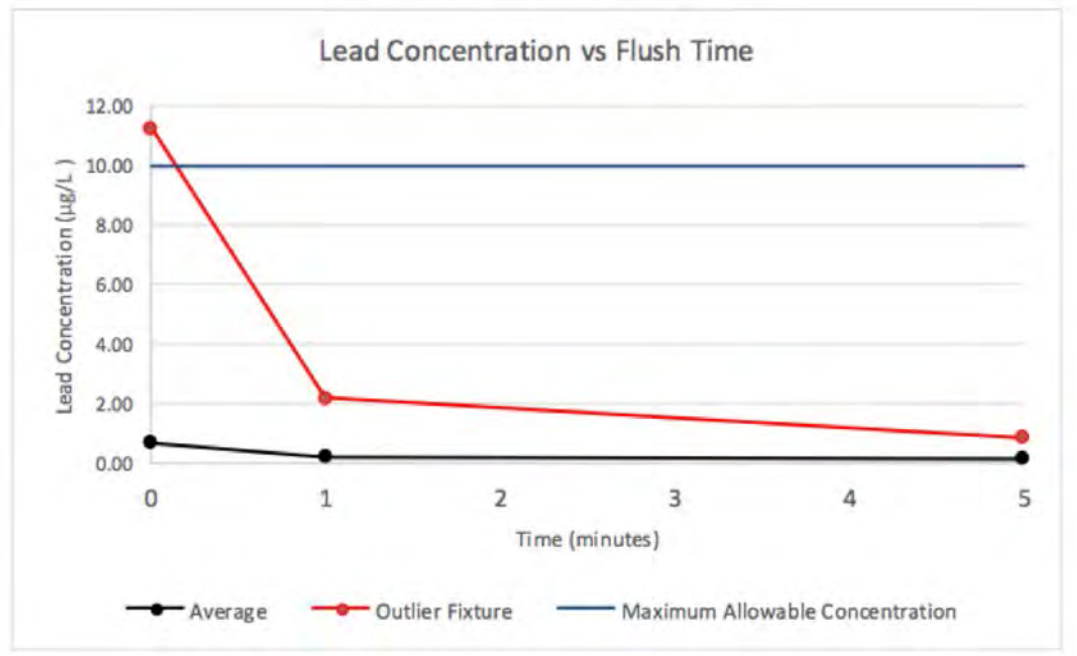
Project Findings

- Lead contamination is present in certain facilities
 - Under normal circumstances, below Health Canada's 10 $\mu\text{g}/\text{L}$
- Flushing for 1 minute results in significant decrease in lead
